Town of Fort Myers Beach

ADA Transition Plan

08/27/2020

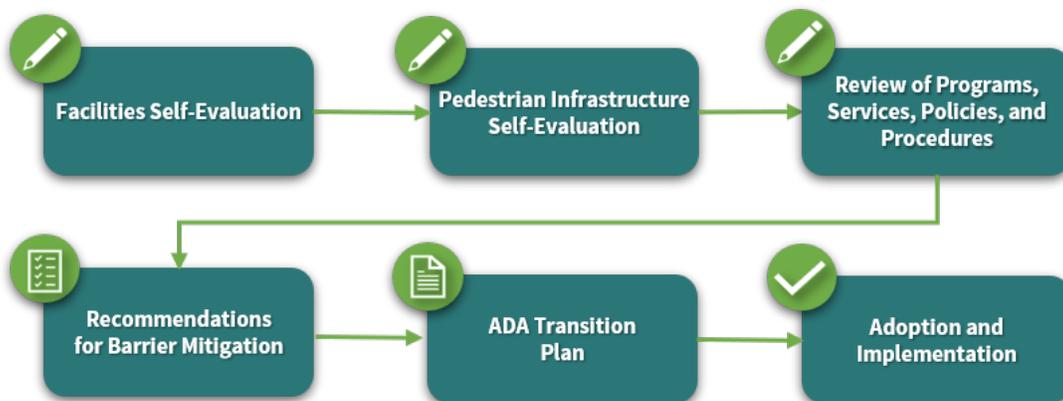
Figure 3.1 Assessment Process

The Transition Plan was developed in coordination with Town staff through several steps including: conducting self-evaluations/field surveys of the facilities and pedestrian infrastructure, reviewing Town programs, services, policies, and procedures, developing recommendations to mitigate the identified barriers to accessibility, drafting the ADA Transition Plan, and implementing the Transition Plan.

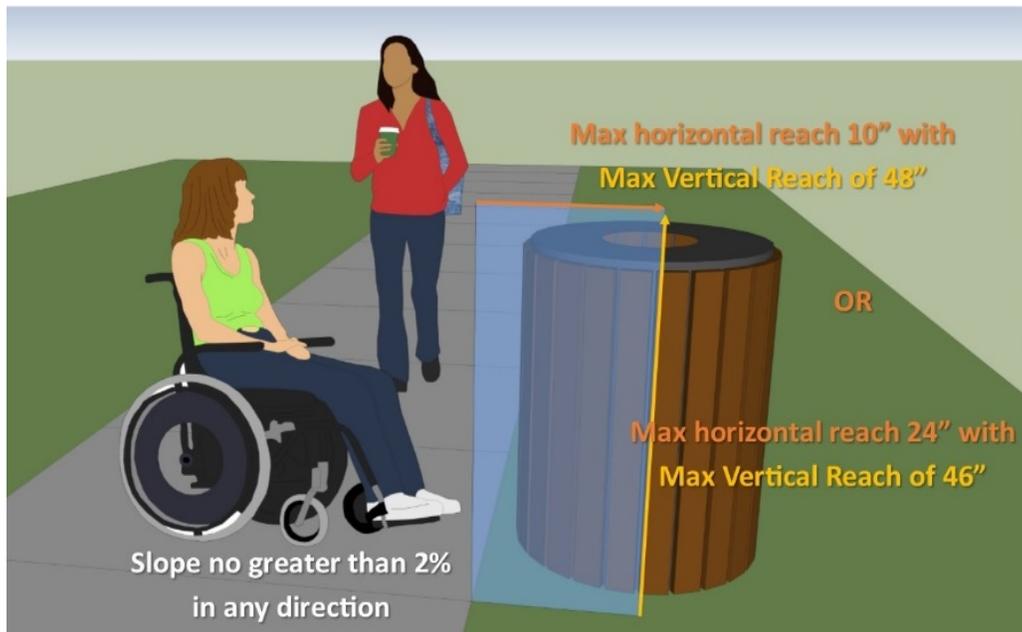
Figure 2.9 Accessible Garbage Can Located Adjacent to Paved Trail

It should be stressed that amenities that are located off the accessible path are considered inaccessible. For items to be accessible, they must be located on, adjacent to, or within reach of a firm, stable, and slip-resistant surface, as shown in Figure 2.9.

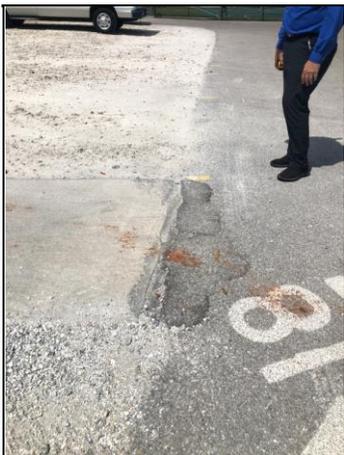
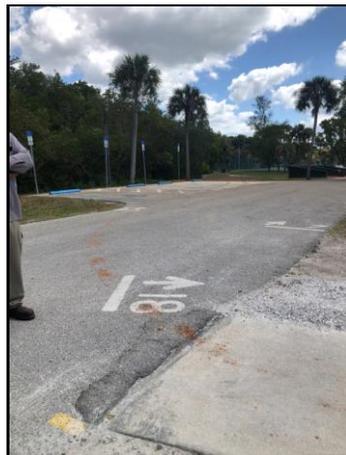
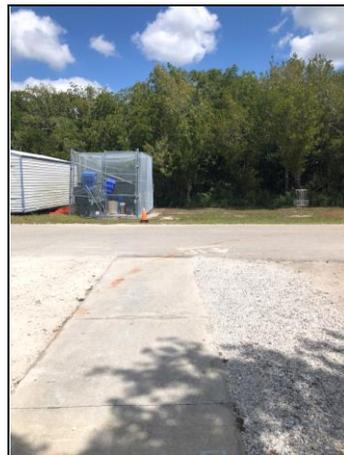
ID: 84 Facility: Bay Oaks Recreation Center/Beach Pool

There are tripping hazards in the accessible route leading from the accessible parking to the entrance.

Repave the area of the sidewalk to remove the bumpy areas in the accessible route. Ensure a firm, stable and slip resistant accessible route with maximum running and cross slopes of 5% and 2% respectively.

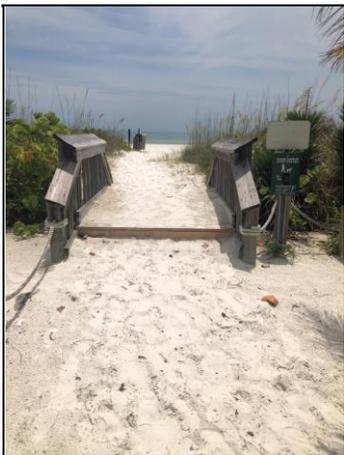
ID: 202 Facility: Aberdeen Beach Access

This beach access is identified as being accessible, yet has no accessible entrance to the beach.

Replace the stairs with a ramp, ensuring the slope does not exceed 8.3% and has compliant handrails, landings, and edge protection. Add a mat over the sand from the parking area to the beach.

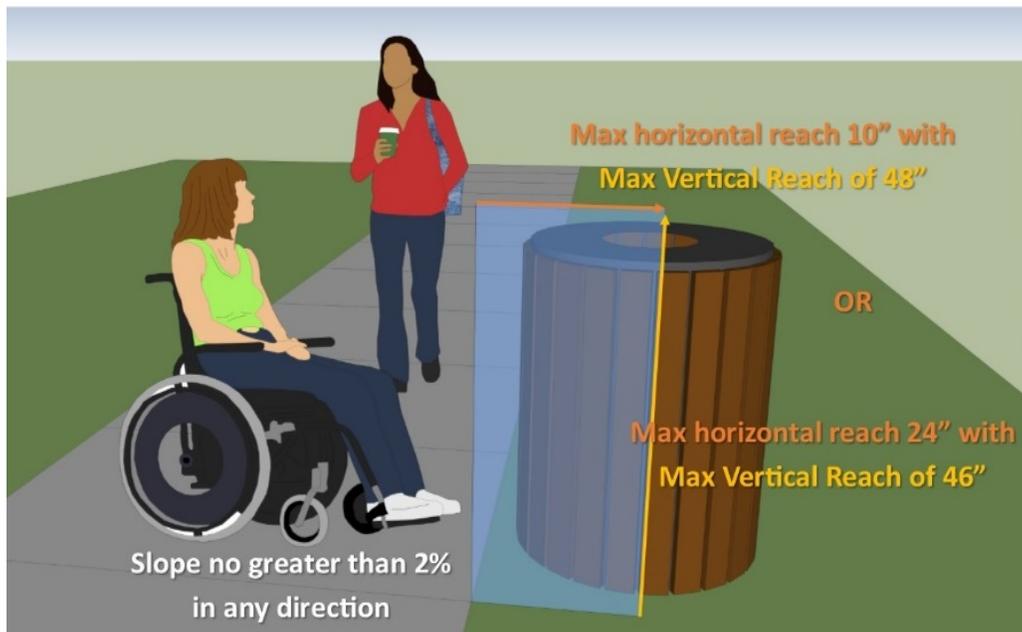
Figure 2.8 Accessible Garbage Can Located Adjacent to Paved Trail

It should be stressed that amenities that are located off the accessible path are considered inaccessible. For items to be accessible, they must be located on, adjacent to, or within reach of a firm, stable, and slip-resistant surface, as shown in Figure 2.8.

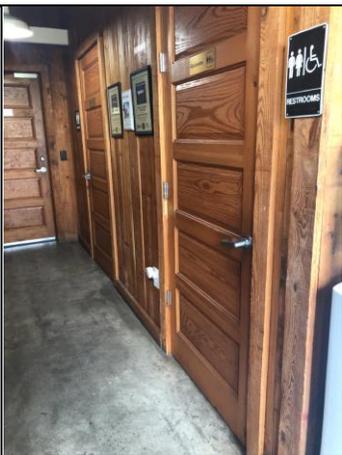
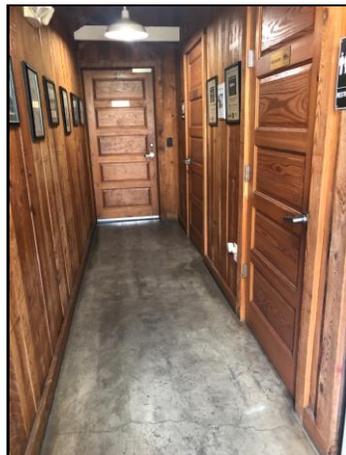
A minimum of a 54" wide hallway is required for doors where a door-closer is present. If a restroom door-closer were not present, then a 48" wide hallway is acceptable. However, door-closers are required for restroom doors.

Consider adding an automatic door opener button to the accessible restroom to make it easier to access with the current hallway width.

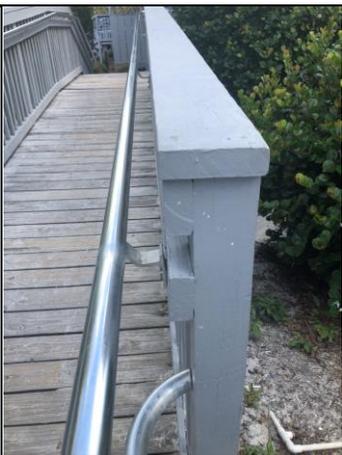
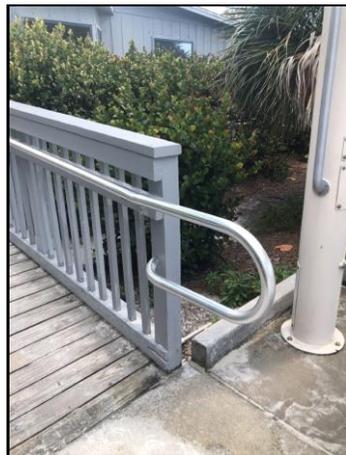
The handrail is loose.

Ensure the handrails are secure in their fittings.

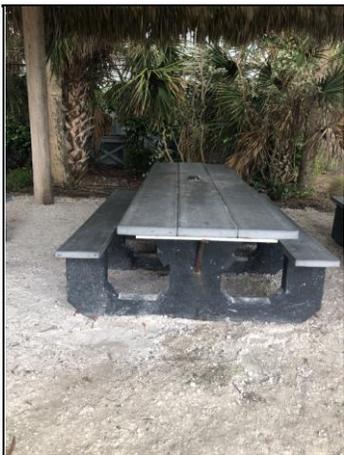
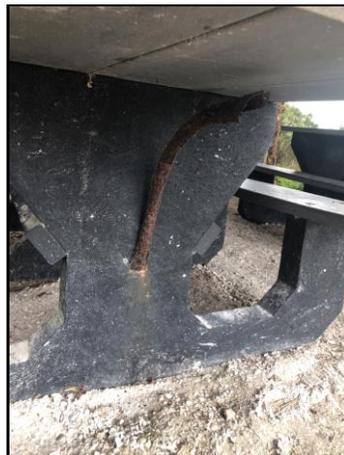
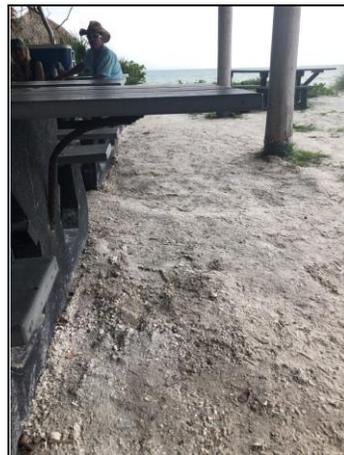
ID: 186 Facility: Newton Park

The ground leading to the accessible picnic table is located in the shell area, therefore not accessible. The table has a rusted angle bracket underneath it.

Pave a firm, stable, and slip resistant accessible route to the accessible end of the table.
Replace the table with one that does not have a bracket underneath impeding on the knee space.

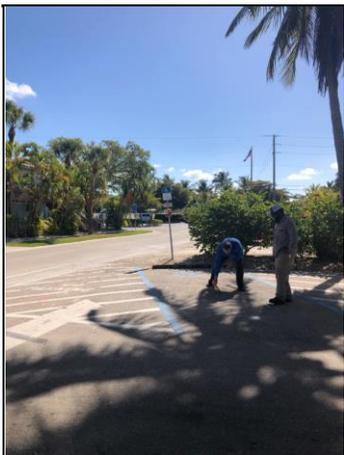
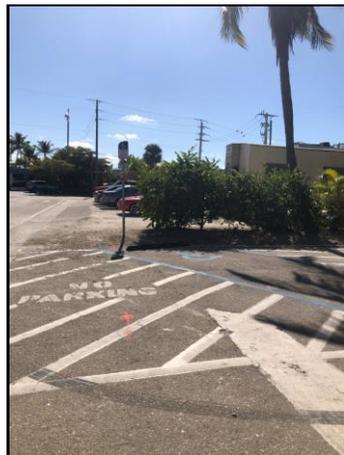
ID: 183 Facility: 2nd St. Parking Lot

The current accessible parking spaces in the nearby lots do not have convenient access to the sidewalks and forces users to wheel or walk behind parked vehicles other than their own, in violation of the FAC.

Relocate the accessible parking spaces for all three nearby surface lots to Crescent and First St. to provide easy access to the nearby sidewalks and businesses.

This location would allow users to not be compelled to travel behind other parked vehicles or travel on the side of the road.

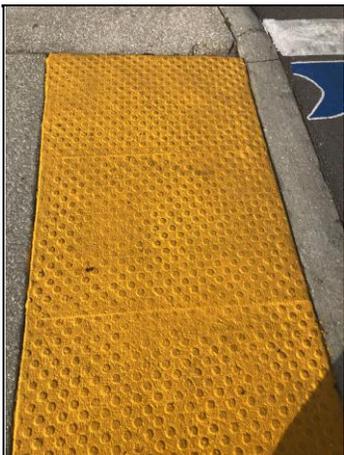
The detectable warnings truncated domes are worn down.

Replace the detectable warnings.

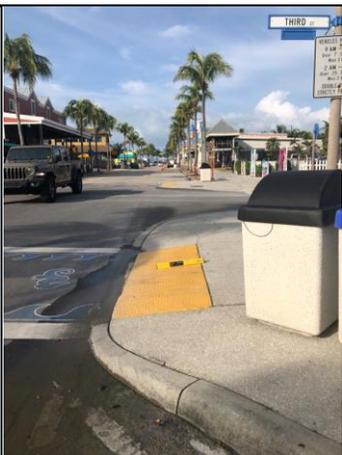
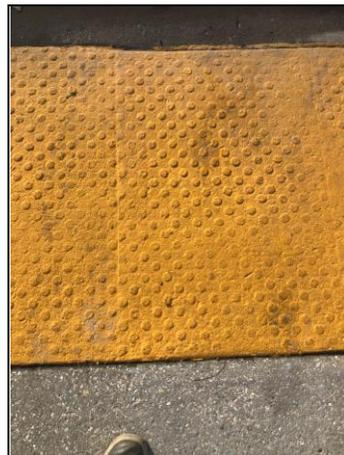
The detectable warnings truncated domes are worn down.

Replace the detectable warning.

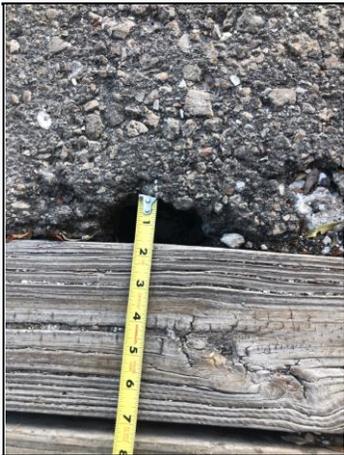
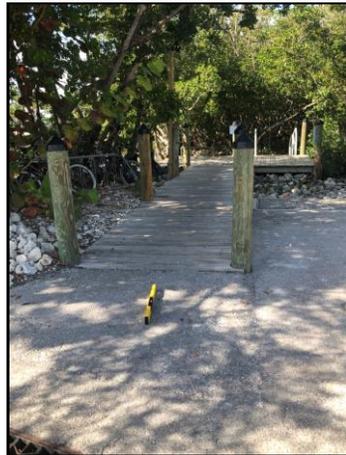
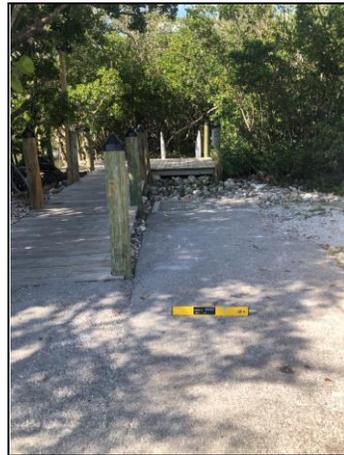
There is a 2" gap between the dock and asphalt posing a tripping hazard. The slope leading to the dock, from the parking lot, has a 4% cross slope.

Fill in the gap.
Resurface the route to reduce the cross slope to a maximum of 2%.

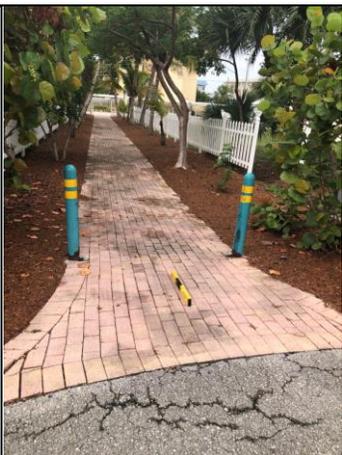
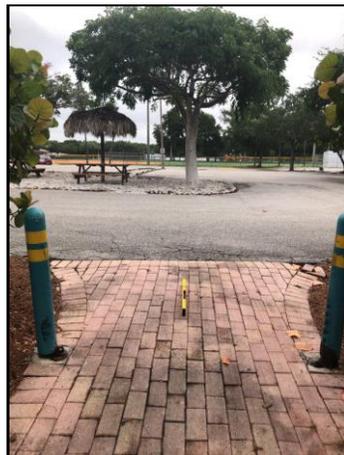
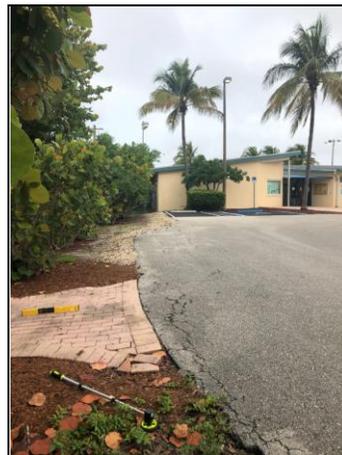
The bricks are heaving and creating a tripping hazard.
The running slope is 6.9% and cross slope is 3%.

Reset the bricks to eliminate the tripping hazard.
Resurface the route to reduce the cross slope to a maximum of 2% and a maximum running slope of 5%. Ensure a level landing is also present.

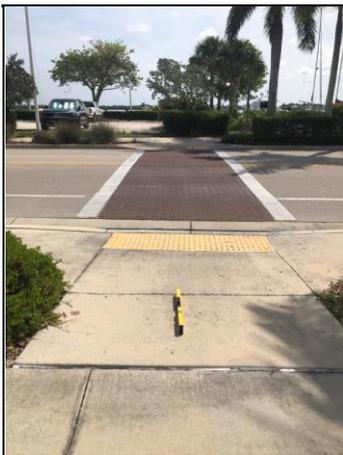
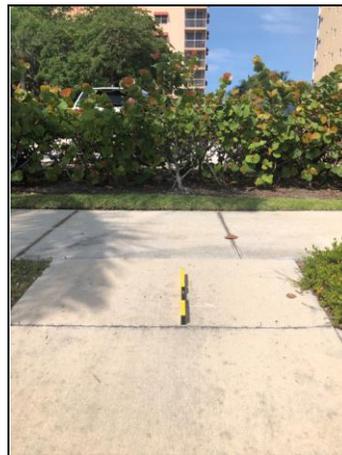
The are open grates in the pathway are 2" in width, posing a tripping hazard.
The running slope is 9.6%.

Replace the grate with one that has gaps that are a maximum of 0.5" in dimension perpendicular to the direction of travel.
Resurface the route to reduce the running slope to a maximum of 5%.

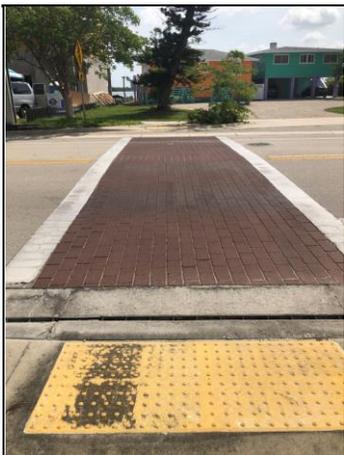
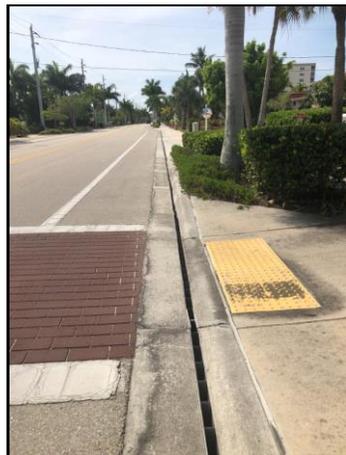
ID: 352 Facility: Sidewalks

The are open grates in the pathway are 2" in width, posing a tripping hazard.

Resurface the gutter to ensure that the running slope is a maximum of 5%.

Replace the grate with one that has gaps a maximum of 0.5" in the dimension perpendicular to the direction of travel.

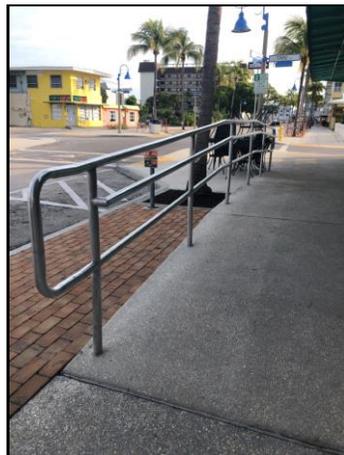
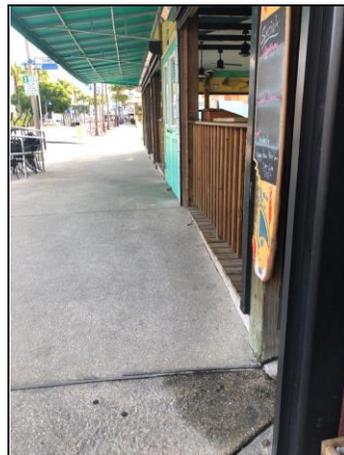
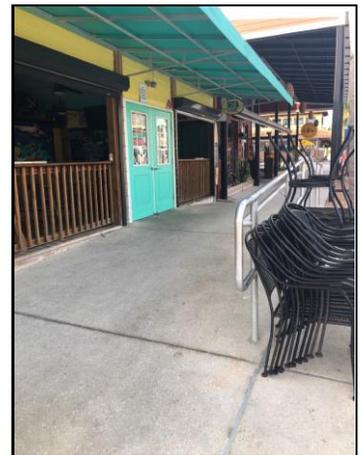
The existing door placement may interfere with the new handrails at the top of the ramp.

Install an additional handrail on the wall side of the ramp at a height of 34” to 38” above the ground. Make sure there are adequate handrail extensions both at the top and bottom of the handrail.

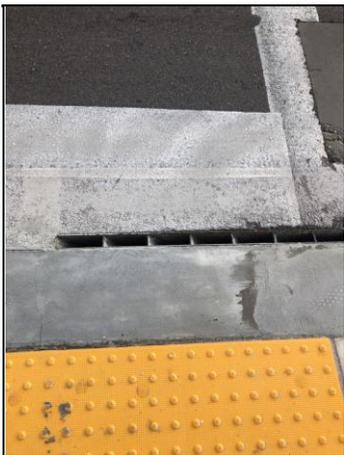
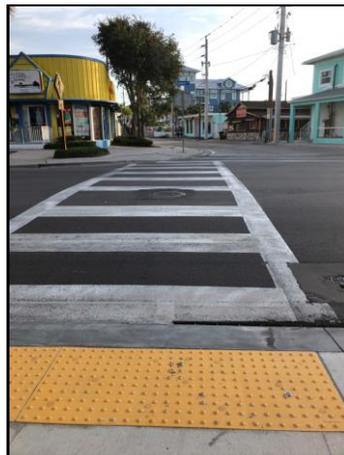
The are open grates in the pathway are 2" in width, posing a tripping hazard.

Replace the grate with one that has gaps that are a maximum of 0.5" in dimension perpendicular to the direction of travel.

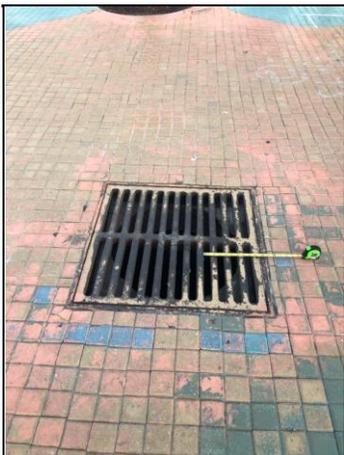
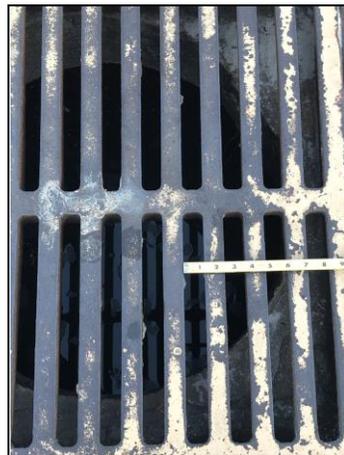
The are open grates in the pathway are 1.25" in width, posing a tripping hazard.

Replace the grate with one that has gaps that are a maximum of 0.5" in dimension perpendicular to the direction of travel.

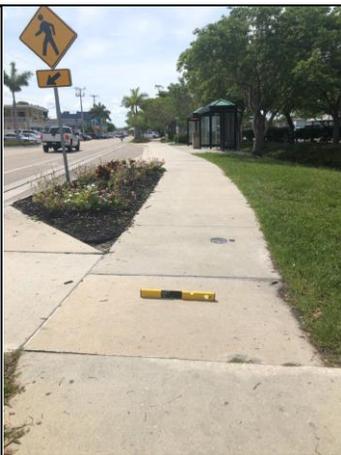
There are open grates in the pathway that are 2" wide, posing a tripping hazard.

Replace the grate with one that has gaps that are a maximum of 0.5" in dimension perpendicular to the direction of travel.

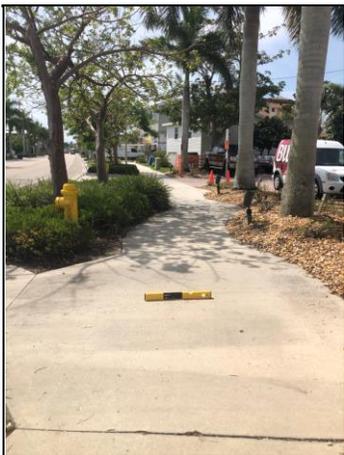
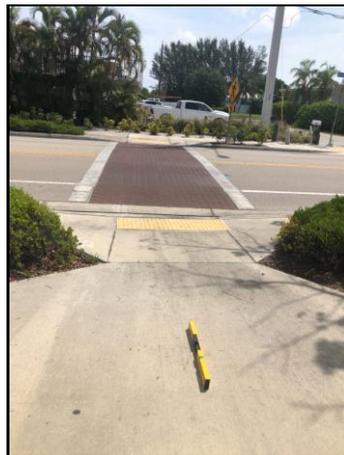
There are open grates in the pathway posing a tripping hazard.

Replace the grate with one that has gaps that are a maximum of 0.5” in dimension perpendicular to the direction of travel.

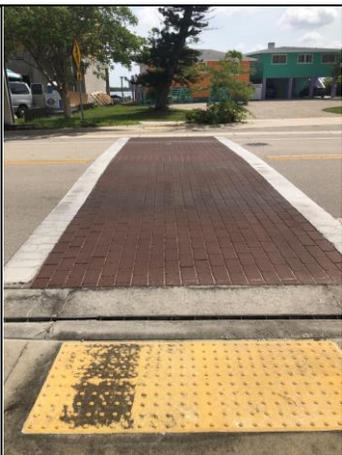
There are open grates in the pathway posing a tripping hazard.

Replace the grate with one that has gaps less than 0.5”.

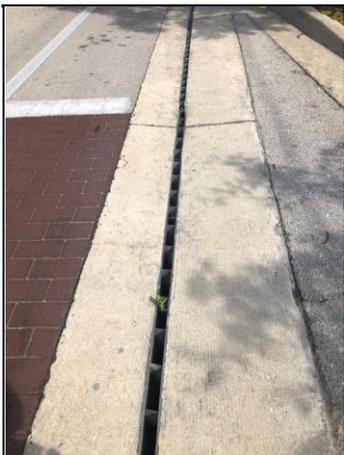
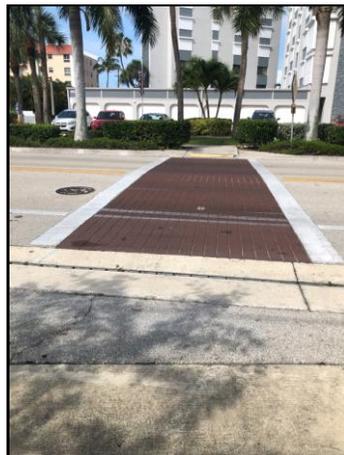
The are open grates in the pathway are 2" in width, posing a tripping hazard.

Replace the grate with one that has gaps that are a maximum of 0.5" in dimension perpendicular to the direction of travel.

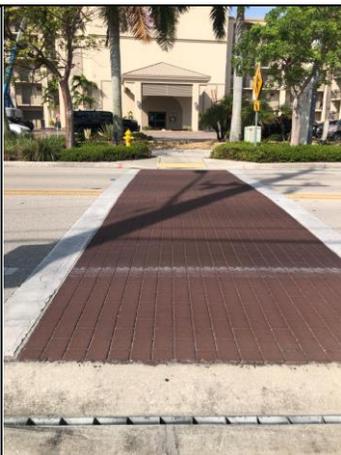
The are open grates in the pathway are 2" in width, posing a tripping hazard.

Replace the grate with one that has gaps that are a maximum of 0.5" in dimension perpendicular to the direction of travel.

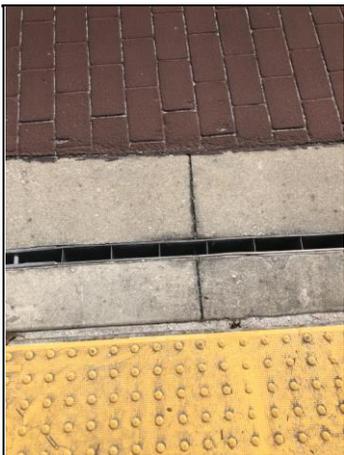
There are open grates in the pathway of 2" posing a tripping hazard.

Replace the grate with one that has gaps that are a maximum of 0.5" in dimension perpendicular to the direction of travel.

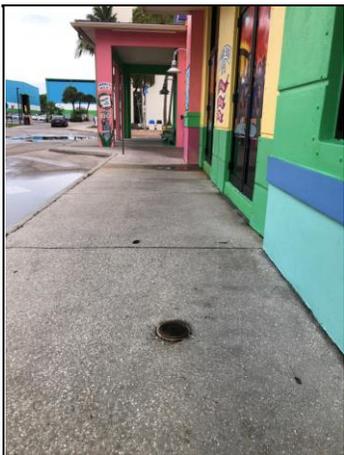
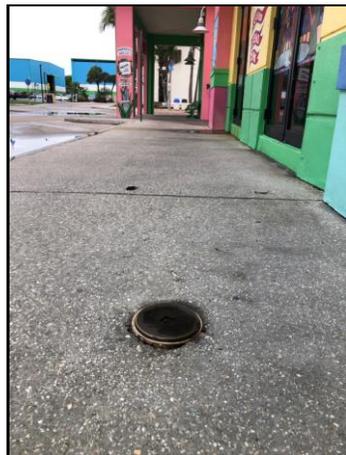
ID:
353

There is a 0.5" tripping hazard in the accessible route.

Resurface the sidewalk to create a smooth transition around the pipe.

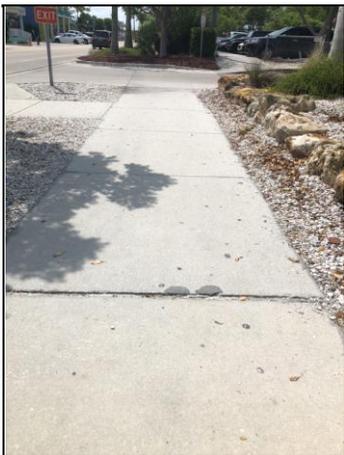
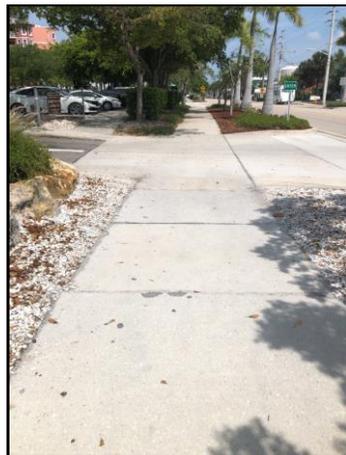
ID: 361 Facility: Sidewalks

There are tripping hazards in the accessible route.

Resurface the sidewalk to remove the raised sections of cement..

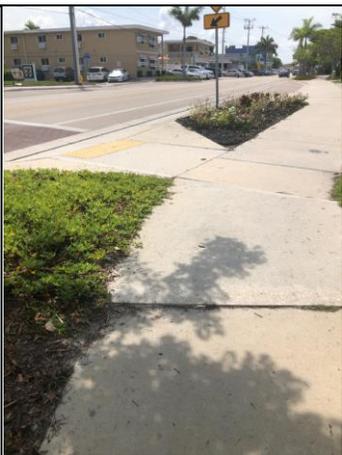
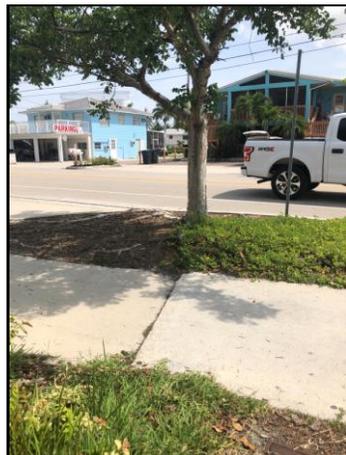
ID:
380

There are tripping hazards in the accessible route.

Repave the sidewalk joints to reduce the tripping hazard to 0.25" or 0.5" if beveled.

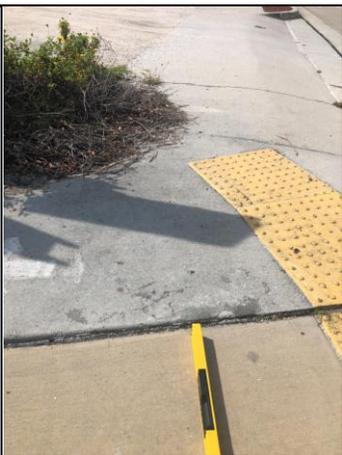
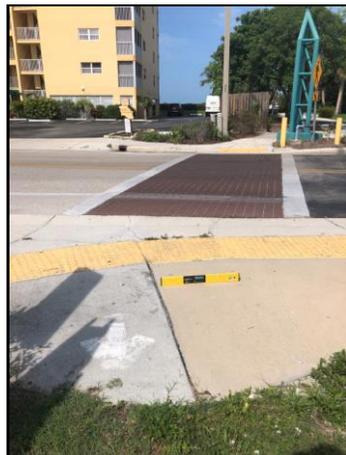
ID:
393

There are tripping hazards in the accessible route.

Repave the transition to ensure it is a maximum of 0.25" or 0.5" if beveled.

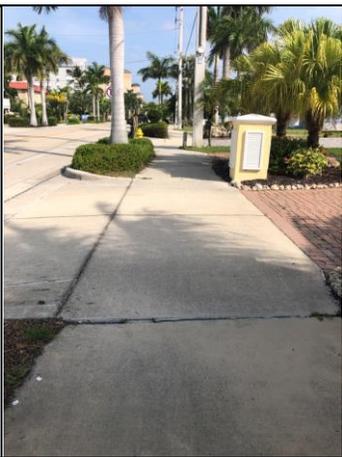
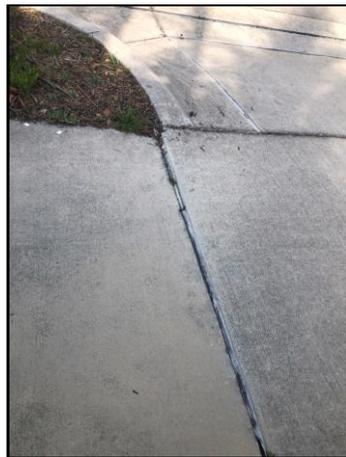
ID:
400

There are tripping hazards in the accessible route.

Resurface the raised area of the sidewalk to remove the bump.

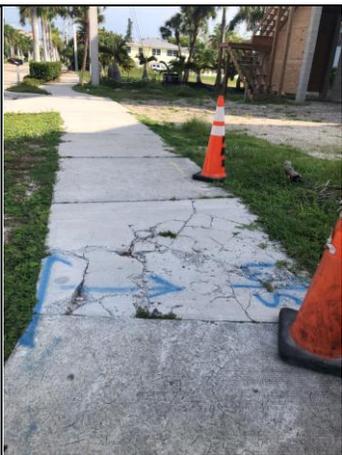
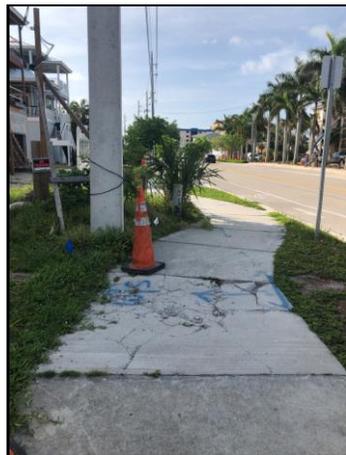
ID: 401 Facility: Sidewalks

There are tripping hazards in the accessible route.

Repave the area of the sidewalk to remove the cracked sections.

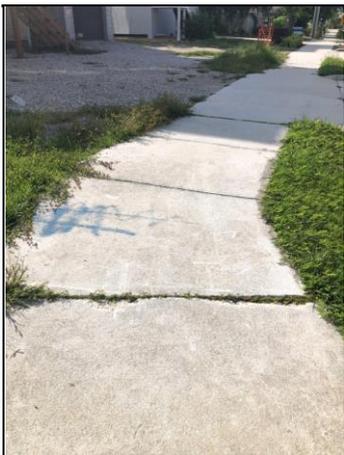
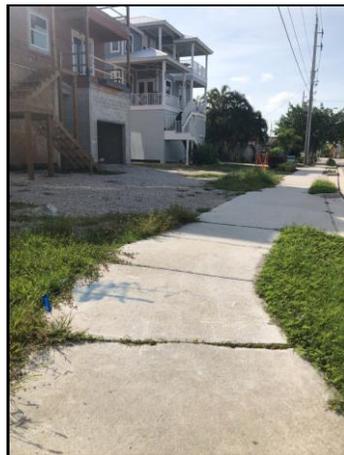
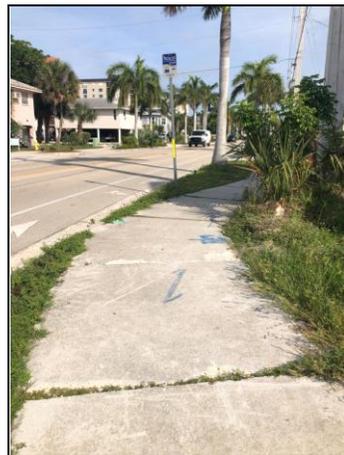
ID:
405

There are tripping hazards in the accessible route.

Repave the area of the sidewalk to remove the tripping hazards.

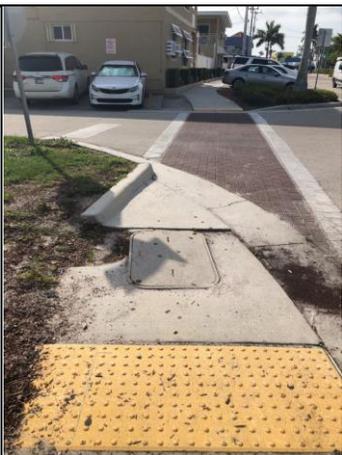
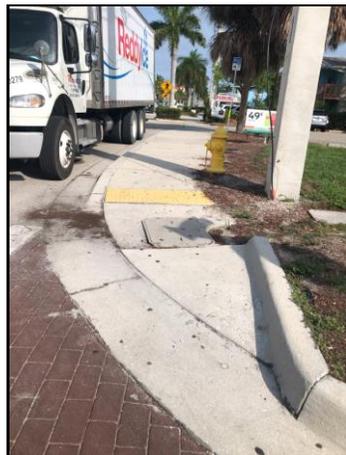
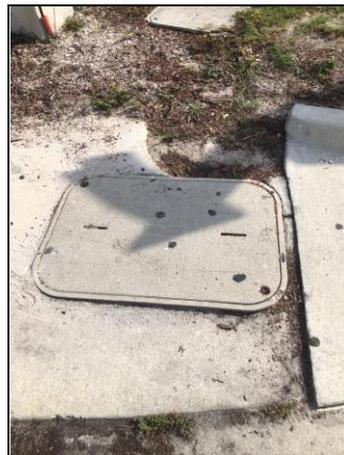
ID:
472

There are tripping hazards in the accessible route.

Repave the sidewalk to make it level with the box cover.

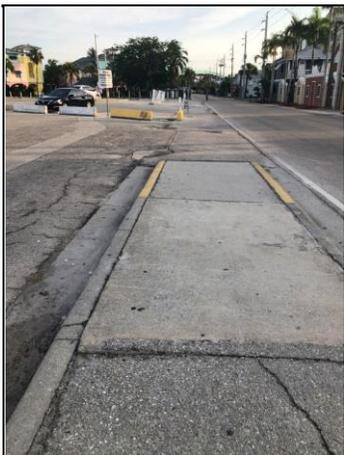
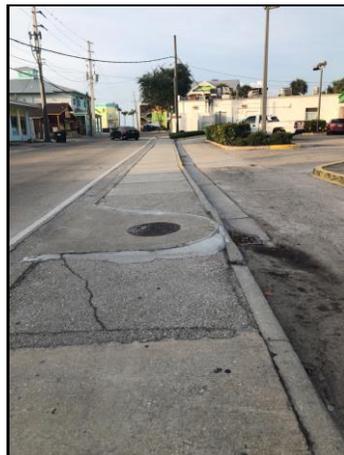
ID:
474

There are tripping hazards in the accessible route that are 0.75" high.

Repave the area of the sidewalk to reduce the height of the tripping hazard to 0.25" or 0.5" if beveled.

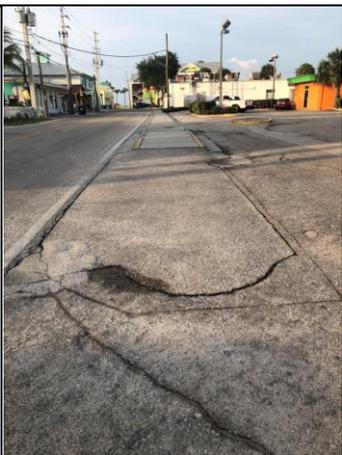
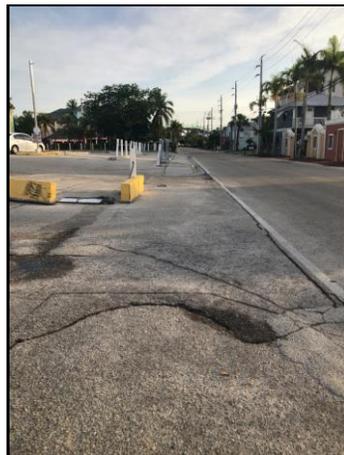
ID:
475

There are tripping hazards in the accessible route.

Fill in the pothole in the driveway.

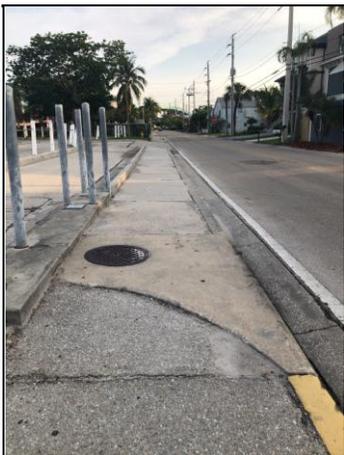
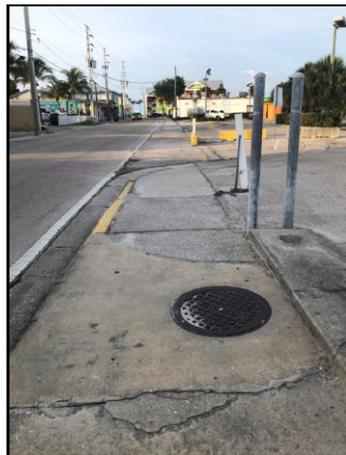
ID:
478

There are tripping hazards in the accessible route that are 0.5" high.

Repave the area of the sidewalk to reduce the height of the tripping hazard to 0.25" or 0.5" if beveled.

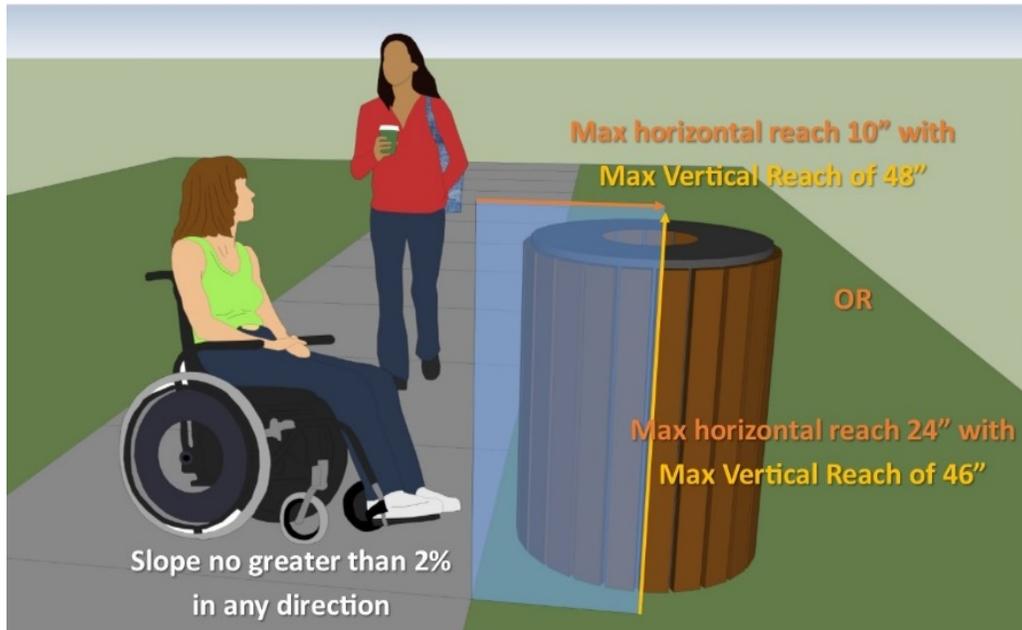
Figure 2.7 Accessible Garbage Can Located Adjacent to Paved Trail

It should be stressed that amenities that are located off the accessible path are considered inaccessible. For items to be accessible, they must be located on, adjacent to, or within reach of a firm, stable, and slip-resistant surface, as shown in Figure 2.7.

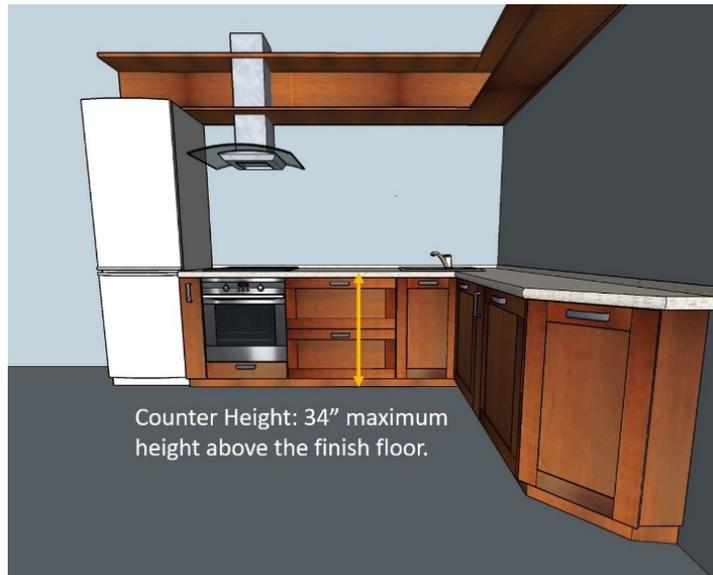
Figure 2.10 Accessible Dining and Work Surface

- Clear floor space complying with §305 positioned for a forward approach shall be provided.
- The tops of dining surfaces and work surfaces shall be 28” minimum and 34” maximum above the finish floor or ground.
- Accessible dining surfaces and work surfaces for children’s use shall comply with §902.4.
